Manhole Inspection Summary

Manhole # S51M__069MH

Insp Date: **9/11/08 10:40 AM**

Location Address: **rear 2937 dillion st.**

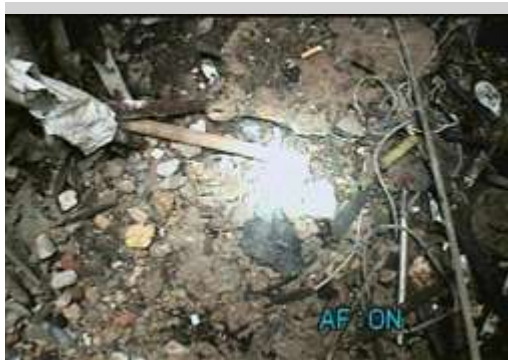
Defect 3

Condition: ☐ Sound ☐ Cracked ☐ Root Intrusion ☐ Deteriorated ☐ Leaks ☒ **Debris**

channel debris

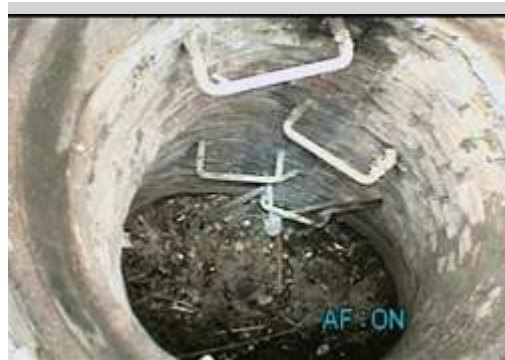
Defect 2

Steps Count: **4** Missing: **0** ☒ **Corroded**

steps

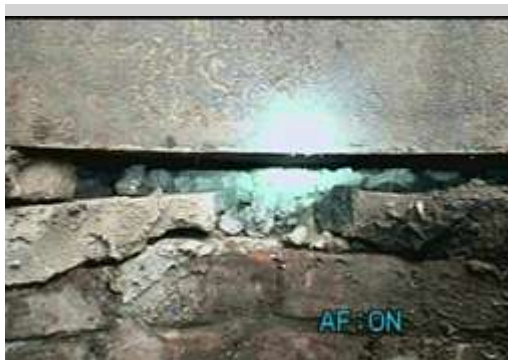
Defect 1

Condition: ☐ Sound ☐ Cracked ☐ Root Intrusion ☒ **Loose Brick** ☒ **Deteriorated**

Infiltration: ☐ None ☒ **Joint** ☐ Cracks ☐ Mortar ☐ Roots ☐ Wall

Loose Bricks and Deterioration in Chimney, Chimney Infiltration

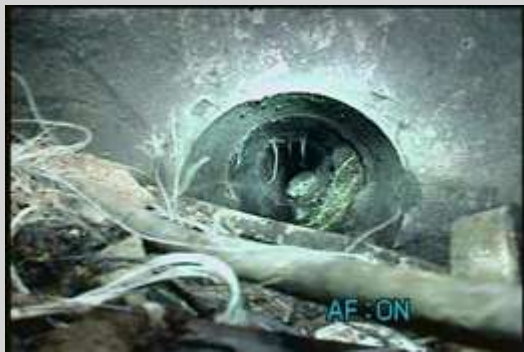
12 O'Clock Outflow

8 in. Circular Gravity Sewer
Pipe Out @ 12 O'Clock

Deposits: ☐ None ☐ Mud ☐ Sludge ☒ **Debris** ☐ Grease

Silt Depth: 3 (in.) Deposits Extent: **Light**
